**Re: Health & Safety Compliance Audit**

**Address Visited:** 107 Main Street, Chryston, Glasgow, North Lanarkshire, G69 9LA

**Appointment Date:** 05 October 2026

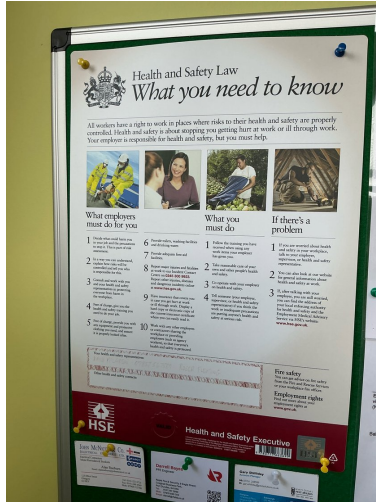
| Ref. | Documentation | Status | Supporting evidence - Action required |
|---|---|---|---|
| 1.3 | Is a copy of the Health and Safety 'What You Need To Know' poster on display? | | <p>The Health and Safety 'What You Need To Know' poster is prominently displayed within the premises where employees have access to the information.</p> <p>Please refer to image(s) under item 1.3 in the Photographs section.</p> |

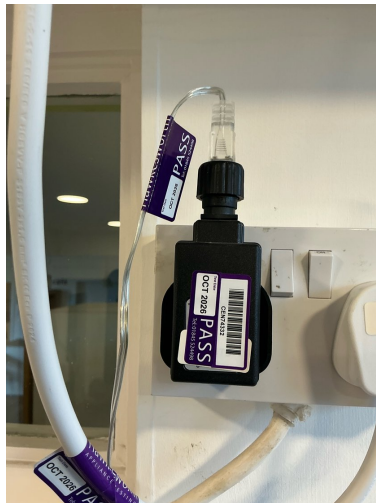
| Ref. | Equipment | Status | Supporting evidence - Action required |
|---|---|---|---|
| 3.6 | Has portable electrical equipment been subject to a periodic inspection and testing? | | Portable electrical appliances are tested for electrical safety within suitable timescales. Last tested on 10/2026<br><br>Please refer to image(s) under item 3.6 in the Photographs section. |

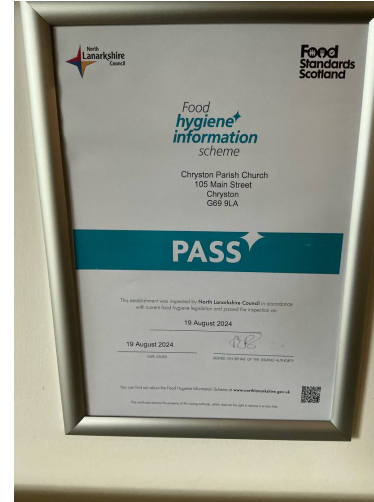
| Ref. | Documentation | Status | Supporting evidence - Action required |
|---|---|---|---|
| 1.16 | Has the business registered with the local authority and has a food hygiene inspection been carried out? | | <p>The business has registered with the local authority and a food hygiene inspection has been carried out. A copy of the hygiene rating notice is on public display.</p> <p>Please refer to image(s) under item 1.16 in the Photographs section.</p> |

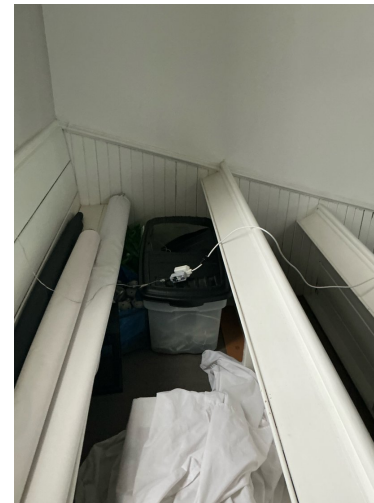
| Ref. | Non-conformity and evidence | Action required | GN No | Agreed Timescale | Status | Allocated to | Completion Date (Initials) |
|---|---|---|---|---|---|---|---|
| 3.19 | Electrical extension leads. There was a multi-point trailing lead adaptor plugged into another multi-point adaptor (daisy chaining effect) and an uncoiled electrical extension reel. This is a serious danger because overloading electrical appliances is a potential fire hazard.<br><br>Please refer to image(s) under item 3.19 in the Photographs section. | Provide additional socket outlets close to where power tools are used so that the use of extension cables can be minimised. This work should be carried out by a competent person. Coiled electrical extension reels should be unwound when in use; a coiled cable drum can quickly overheat. Make sure all employees are aware of the correct way to use extension leads and the potential hazards. | 4-1 | Six weeks | | David McLaren | |

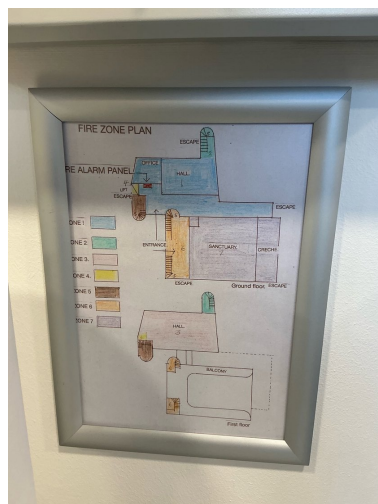
| Ref. | Fire | Status | Supporting evidence - Action required |
|---|---|---|---|
| 4.5 | Is there a fire and emergency evacuation procedure with a fire building plan? | | There is an up to date written fire and emergency evacuation procedure in place along with a plan identifying final exits escape route and equipment.<br><br>Please refer to image(s) under item 4.5 in the Photographs section. |

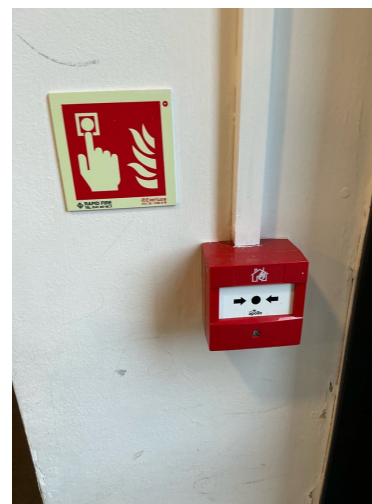
| Ref. | Fire | Status | Supporting evidence - Action required |
|---|---|---|---|
| 4.14 | Are all the fire alarm operating points easily accessible? | | Fire alarm operating points throughout the building were all easily accessible.<br><br>Please refer to image(s) under item 4.14 in the Photographs section. |

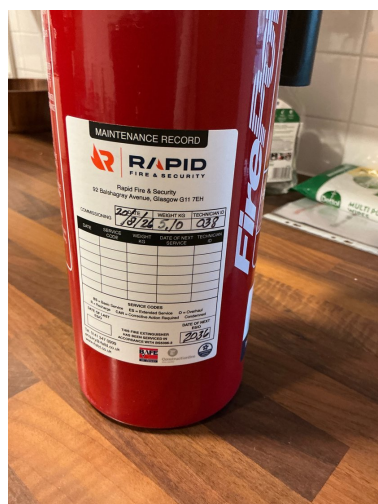
| Ref. | Fire | Status | Supporting evidence - Action required |
|---|---|---|---|
| 4.17 | Has appropriate fire fighting equipment been provided and serviced at least every 12 months? Are fire extinguisher identification signs adjacent to extinguishers? | | Fire fighting equipment is subject to periodic checks and annual maintenance by a recognised fire safety contractor. Suitable fire extinguisher identification signs are displayed adjacent to the extinguishers. Carried out by Rapid fire on 20/08/2026.<br><br>Please refer to image(s) under item 4.17 in the Photographs section. |

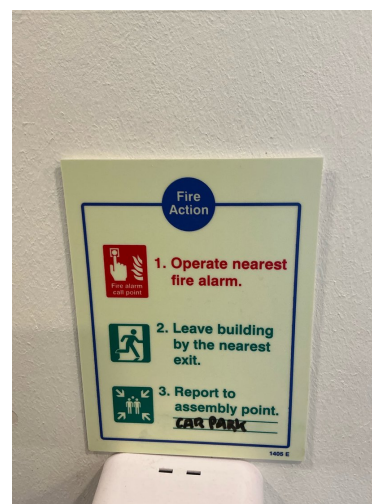
| Ref. | Fire | Status | Supporting evidence - Action required |
|---|---|---|---|
| 4.21 | Are suitable fire exit signs and evacuation instructions on display in appropriate places on fire exit routes? | | Suitable fire exit signs are in place.<br><br>Please refer to image(s) under item 4.21 in the Photographs section. |

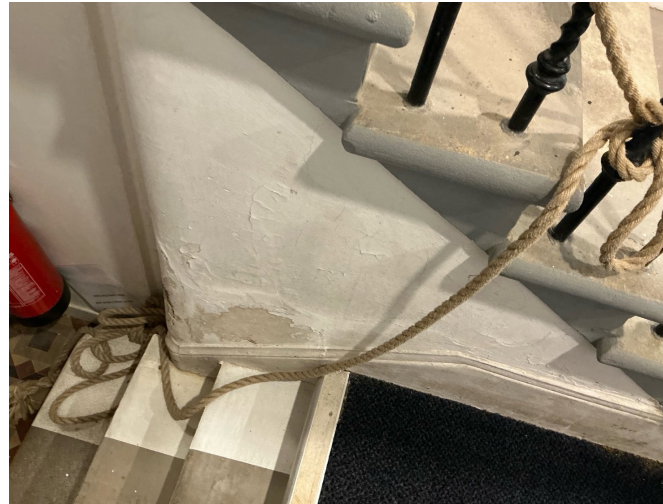
| Ref. | Non-conformity and evidence | Action required | GN No | Agreed Timescale | Status | Allocated to | Completion Date (Initials) |
|---|---|---|---|---|---|---|---|
| 6.20 | Arrangements to keep walkways free from slip, trip and fall hazards. A trailing rope were observed to be creating tripping hazards.<br><br>Please refer to image(s) under item 6.20 in the Photographs section. | Slip, trip and fall hazards should be avoided at all times. Cables should be routed away from walkways, where trailing cables cannot be avoided cable mats should be used. Conduct on going checks to make sure good cable management is in place. | 4-8 | Six weeks | | David McLaren | |
